DEPARTMENT OF TRANSPORTATION

Contract #: 04-0120F4Cty: SF/ALA Rte: 80 PM: 13.2/13.9File #: 69.28**WELDING INSPECTION REPORT****Resident Engineer:**Siegenthaler, Peter**Address:** 333 Burma Road**City:** Oakland, CA 94607**Report No:** WIR-020268**Date Inspected:** 05-Feb-2011**Project Name:** SAS Superstructure**OSM Arrival Time:** 700**Prime Contractor:** American Bridge/Fluor Enterprises, a JV**OSM Departure Time:** 1900**Contractor:** Zhenhua Port Machinery Company, Ltd (ZPMC), Changxing Island **Location:** Shanghai, China**CWI Name:** Qiu Wen**CWI Present:** Yes No**Inspected CWI report:** Yes No N/A**Rod Oven in Use:** Yes No N/A**Electrode to specification:** Yes No N/A**Weld Procedures Followed:** Yes No N/A**Qualified Welders:** Yes No N/A**Verified Joint Fit-up:** Yes No N/A**Approved Drawings:** Yes No N/A**Approved WPS:** Yes No N/A**Delayed / Cancelled:** Yes No N/A**Bridge No:** 34-0006**Component:** OBG**Summary of Items Observed:**

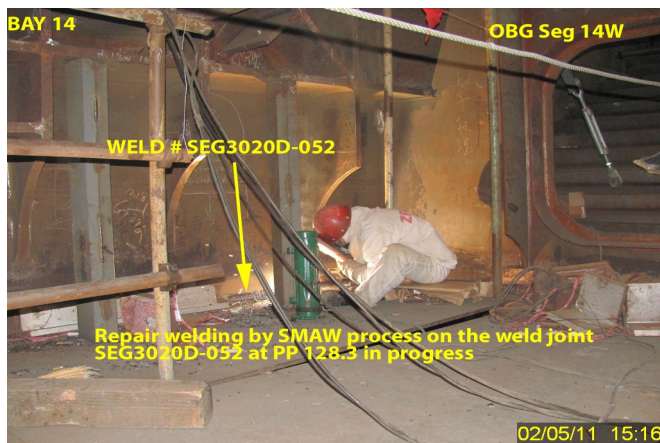
Repair welding of weld joint no: SEG3020D-052 [Bottom Plate (BP) 3092A to Floor beam (FB) 3343A, complete joint penetration (CJP) weld at panel point (PP) 128.3]. The welder is identified as 066038 and was observed welding in the 2G position. Welding process was identified as Shielded Metal Arc Welding (SMAW). ZPMC QC was identified as Mr. Wang Xiang Pin. The welding variables recorded by this QC appeared to comply with WPS: 345-SMAW-2G(2F)-FCM-Repair. Repair welding was done as per Critical Welding Repair (CWR) Report: B-CWR 2734 Rev-1. (Photograph is attached herewith).
